**SAS Superstructure**

Daily Diary Report by Bid Item

Contract No.: 04-0120F4

Diary #: 151 Const Calendar Day: 47 Date: 21-Jul-2012 Saturday

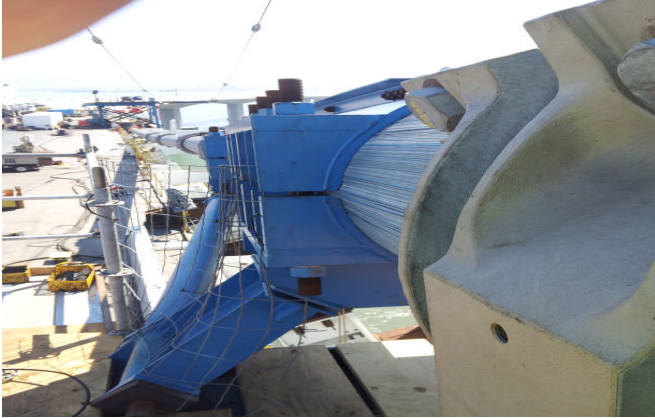
(3) I also informed Warren about near the South Main catwalk anchorage near PP 102E, some wires were bunched up around the edges of the catwalk anchorage (Refer to attached pictures). I also observed that there was no sign of damage wires on the main cable. I took several pictures of this issue yesterday and made a longitudinal and vertical reference mark in case the catwalk anchorage slips during load transfer.

North Side span catwalk anchorage near PP 102_ Bunched wires

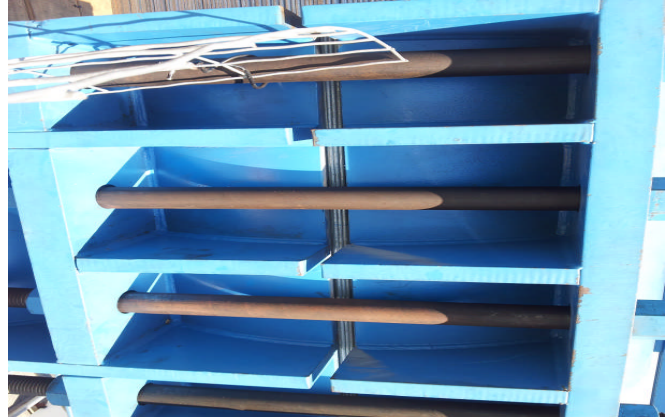
North Side span catwalk anchorage near PP 102_ Bunched wires

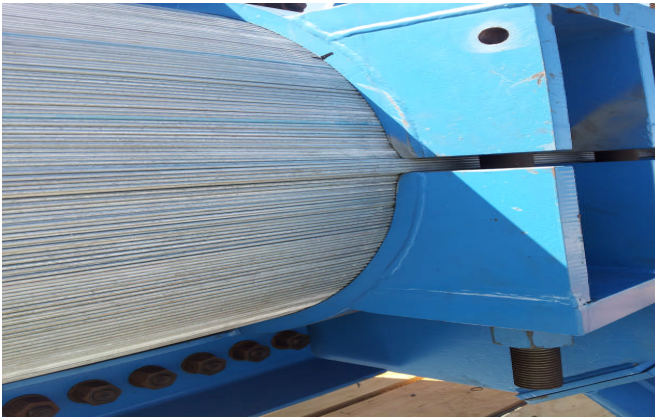
North Side span catwalk anchorage near PP 102_ Bunched wires

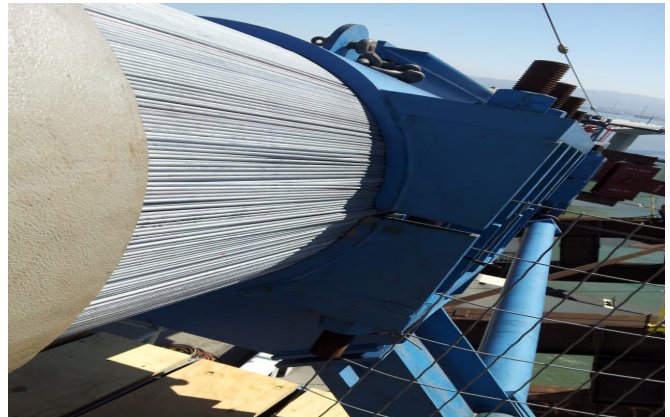
North Side span catwalk anchorage near PP 102_ Bunched wires

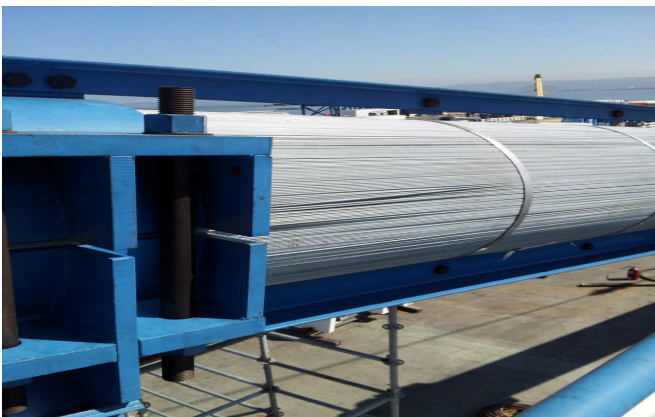
North Side span catwalk anchorage near PP 102_ Bunched wires

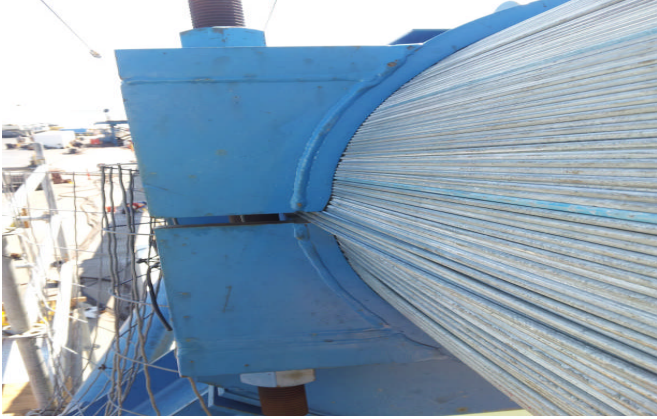
North Side span catwalk anchorage near PP 102_ Bunched wires
